INVESTIGATIONS OF MURAL PAINTINGS OF SETI I AND RAMESES II TEMPLES AT ABYDOS – EGYPT

Ehab AL-EMAM^{1*}, Mohamed EL-GOHARY¹, Mohamed ABD EL HADY²

Abstract

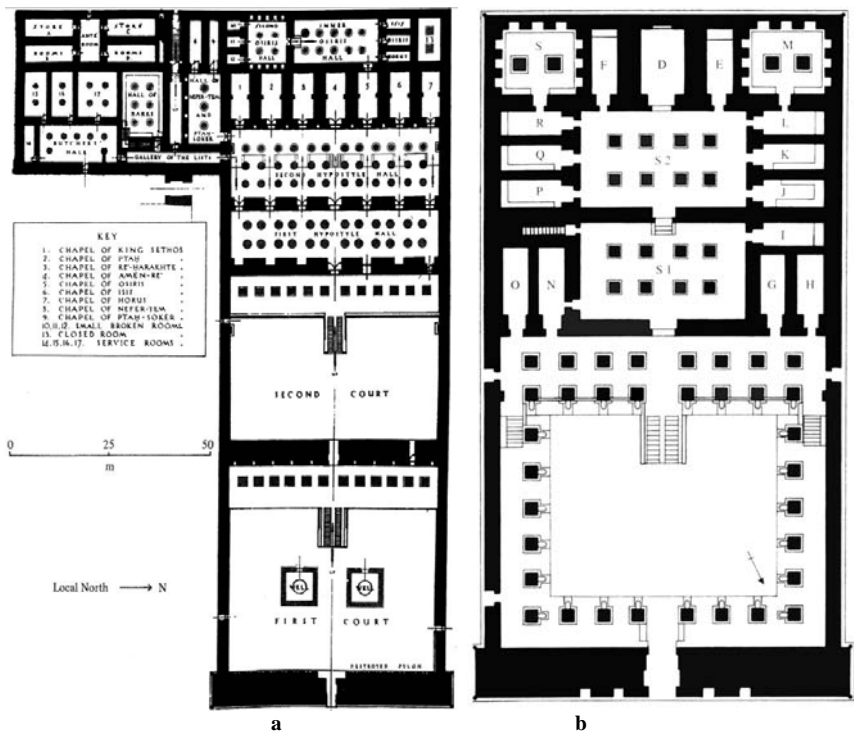
Fig. 2. Plan of the temple of Seti I at Abydos: a -After David, 1981 and plan of the temple of Ramesses II at Abydos; b - After Breitenstein,1999.

The temple of Seti I is the largest well-preserved building of the New Kingdom [2]. However, Seti I died before finishing the temple which was completed by his son Ramesses II. The plane of the temple is unique as it takes the shape of capital L (Fig. 2a), this may be due to the presence of an underground canal of water that made the foundation unsafe. Afterwards, this canal was enclosed by the Osireion. The technique of Seti's artists was unsurpassed; as his sculptures are in low relief and characterized by a wonderful delicacy of line and detail. While the style of art had changed in Ramesses II's time or whether Ramesses was employing inferior artists; but it is very noticeable that the work of Ramesses is inferior to that of Seti. Since the work is in hollow-relief, too deeply cut, and is entirely without the delicacy and finish of the earlier period [7].

temple of Seti I, the design of the temple of Ramesses II is more standard and is patterned after contemporary royal mortuary temples at Thebes [6] (Fig. 2b).

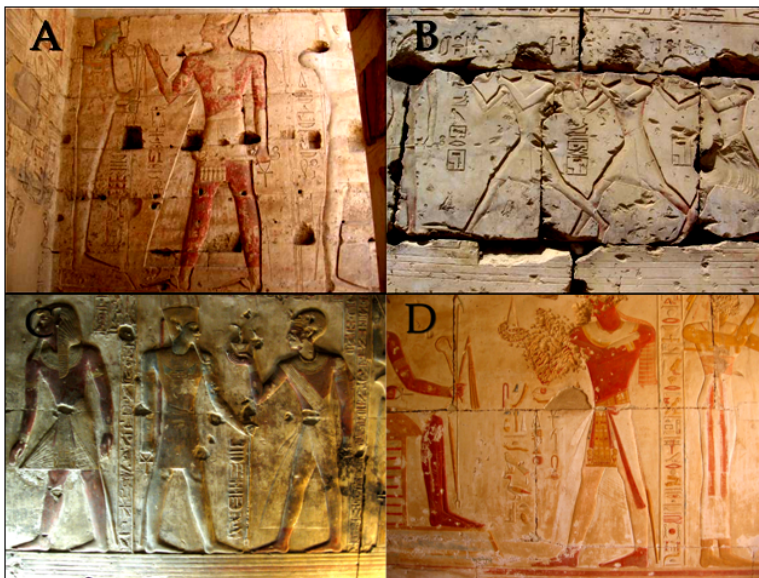
Fig. 3. Combination of sunk/raised relief in the murals of façades:

- A - Sunk relief and combination of sunk/raised relief in the temple of Seti I;
- B - Sunk relief and combination of sunk/raised relief in the temple of Ramesses II;
- C - Raised relief from one of the seven chapels in the temple of Seti I;
- D - Raised relief from one of the small chapels in the temple of Ramesses II.

Visual examination reveals that most of the two temples murals were carved on stone and the ancient artist used sunk relief and a combination of sunk/raised relief in the murals of façades which are exposed to sunlight, while he mostly used raised relief in the internal murals (Fig. 3). In some cases, the artist covered these reliefs with a thin layer of rendering before the application of paints, while in others he did not depend upon this layer; as he just applied a thin white layer on the reliefs to receive paints (Fig. 4A and B). However, the temple of Seti I contains some unfinished murals; as the artist carved the scene and applied the rendering layer without painting them (Fig. 4C). In addition, there are exceptions; as the artist performed his colored scenes directly on a rendering without carving. This clearly appears in the Hall of Barques in the temple of Seti I (Fig. 5).

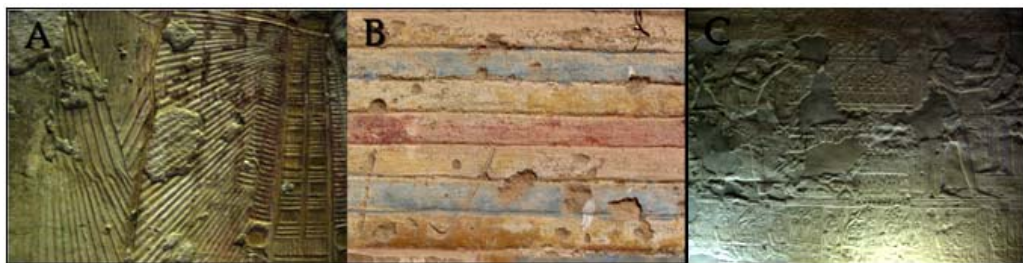
Fig. 4. Different preparation layers:

- A - Flaking parts of the rendering layer from a mural painting in the temple of Seti I;
- B - Paint layer over a white thin layer applied directly on the stone in the temple of Ramesses II;
- C - Unfinished scene from the temple of Seti I.

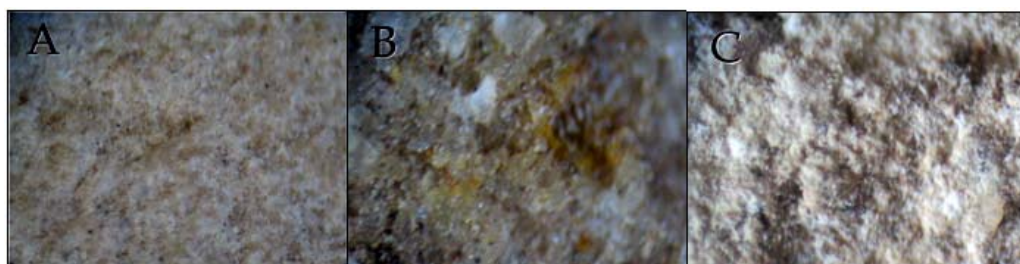
Fig. 6. Optical photomacrography of stone and mortar samples from the temple of Seti I under stereomicroscope:
A -Limestone sample shows homogeneous fine-grained structure (70X);
B -Sandstone sample shows particles of quartz differ in their size. In their shape, they are angular and sub-rounded. Some particles are coated with red/yellow color (70X);
C - Mortar sample shows the presence of fine quartz particles (70X).

The limestone sample of the temple of Seti I reveal homogeneous fine-grained structure under stereomicroscope (Fig. 6A). This is so clear in the prepared thin section, which shows fine grained calcite matrix (Fig. 7A, B and C). A scratch of the sample examined under plane-polarized light (PPL) reveals some euhedral rhombs of dolomite particles (Fig. 8).

A sandstone sample collected from the temple of Seti I is examined under stereo microscope and revealed that it is mainly composed of quartz particles; some of them are angular while others are sub-rounded. The particles differ in their size, and some are coated with red/yellow color (Fig. 6B). A thin section of the same sample illustrates sub-rounded and angular particles under PPL, and shows strong birefringent under cross polarized light (XPL) (Fig. 7D, E and F).

The mortar sample, obtained from the temple of Seti I, under stereomicroscope shows fine particles of quartz and apparent porosity (Fig. 6C).

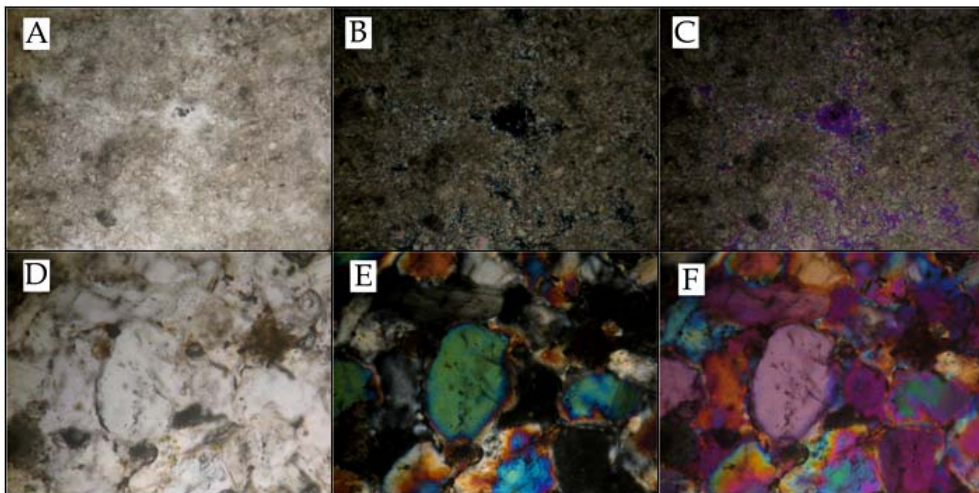
Fig. 7. Thin sections of limestone and sandstone samples from the temple of Seti I:
 A - Limestone/PPL/100X: microcrystalline calcite matrix; B - Limestone/XPL/100X: The same field under crossed polars; C - Limestone/ The same field under the 1st order red compensator; D - Sandstone/PPL/100X: Sub-rounded/angular particles of quartz which differ in their size; E - Sandstone/XPL/100X: The same field under crossed polars shows strongly birefringent particles; F - Sandstone/ The same field under the 1st order red compensator.

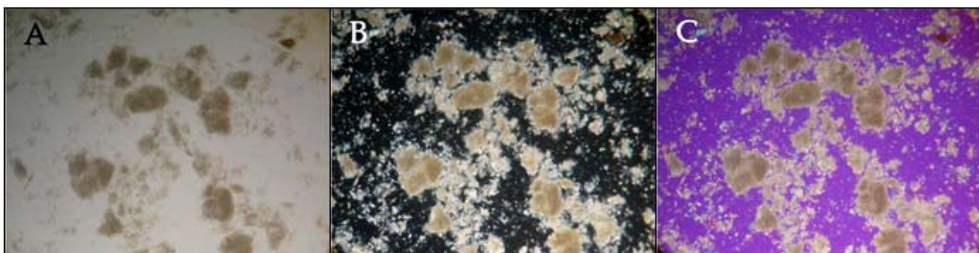
Fig. 8. Optical photomicrographs of limestone sample from the temple of Seti I:
 A - PPL/100X: Fine Spherical grains of limestone with euhedral rhombs of dolomite particles;
 B - XPL/100X: The same field under crossed polars;
 C - The same field under the 1st order red compensator.

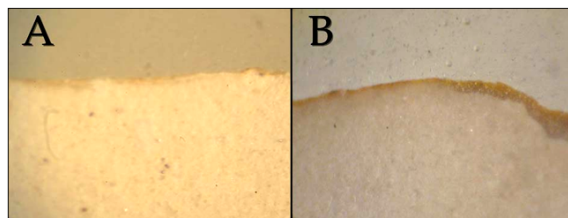
Fig. 9. Optical photomicrograph of polished cross sections samples:
 A - Sample (SY) shows a thin yellow paint layer applied on a fine rendering (70X);
 B - Sample (S-Barques) illustrates a yellow layer applied on a fine rendering (70X).

The cross sections of paint layer samples provide information about the different types of rendering used in both temples (Figs. 9, 10 and 11). In addition to this, many samples were examined under stereomicroscope, and this concluded to that most of the samples are composed of coarse lime rendering, others are from fine lime rendering, and just two are characterized by multi-layers of lime and clay (Fig. 12).

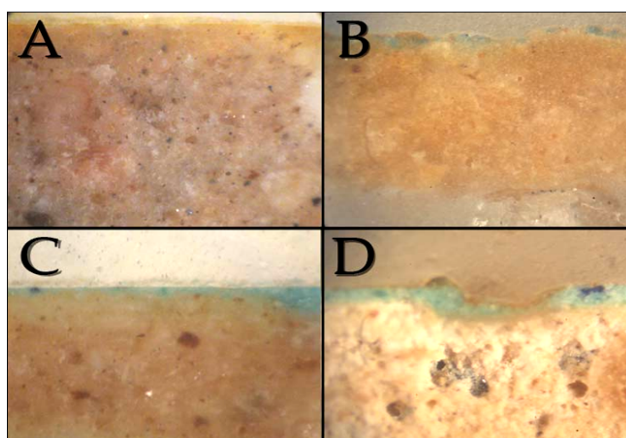
Fig. 10. Optical photomacrography of polished cross sections samples:

- A - Sample (RKY) shows a thin yellow paint layer applied on a coarse rendering (30X);
- B - Sample (ROB) reveals a faded blue layer applied on a coarse rendering (70X);
- C - Sample (ROG) shows uneven pale green layer applied on a coarse rendering (70X);
- D - Sample (S6G) illustrates a relatively thick green layer applied on a coarse rendering, also characterized by the presence of blue particles (70X).

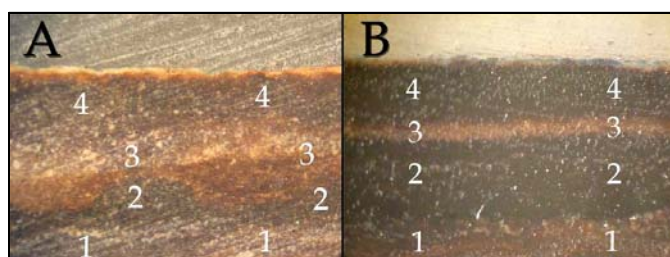
Fig. 11. Optical photomacrography of polished cross sections samples:

- A - Sample (S6R) shows a degraded red paint layer applied on a thin white wash and a rendering composed of four distinguished layers of lime and clay (70X);
- B - Sample (S6B) shows a degraded blue paint layer applied on a thin white wash and a rendering composed of four distinguished layers of lime and clay (70X).

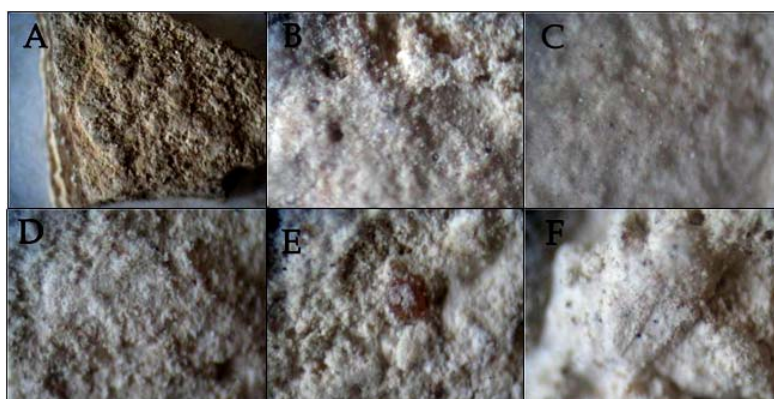
Fig. 12. Optical photomicrographs of different rendering layers from both temples under stereomicroscope:

- A - Sample (S6B) shows coarse rendering composed of multi-layers of lime and clay (10X);
- B - Sample (S6G) shows coarse rendering (70X);
- C - Sample (S-Barques) shows fine rendering (70X);
- D - Sample (RR1) shows coarse rendering (70X);
- E - Sample (RKY) shows coarse rendering with remarkable large particle of quartz (70X);
- F - Sample (RY) shows coarse rendering (70X).

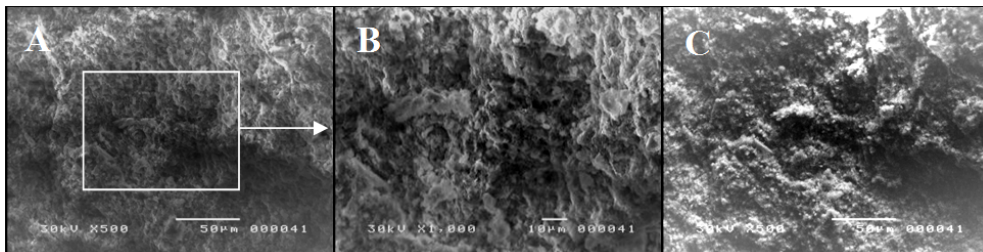
Fig. 13. SEM photomicrographs of limestone sample from the temple of Seti I:

- A - Fine grains of microcrystalline calcite (500X);
- B - The same field under 1000X magnification;
- C - The same field under backscattered electrons (BSE) 500X.

SEM micrographs show the fine grains of microcrystalline calcite (Fig. 13). EDS analysis (Tab. 2) shows Ca, O and C as the main elements with the presence of Al, Cl, K, Mg, Na, Si and S in small amounts. This is related to the outcomes of the XRD analysis which presents calcite as the major mineral, with minor amounts of magnesite, kaolinite, hellibrandite, and dolomite. In addition, thenardite, halite and aluminum silicate present in the sample as traces (Fig. 17A). Moreover, El-Gohary [10] reached, with the aid of the X-ray fluorescence (XRF) technique, that the limestone of the temple of Ramesses II contains mainly Ca then Te, Si and Mg with little amounts of Al and K. The XRD analysis reveals that the main mineral is calcite then dolomite, quartz, anhydrite and gypsum. Similar analytic studies were carried out on mural paintings in order to determine the chemical composition [11, 12] and microbiological attack [13, 14].

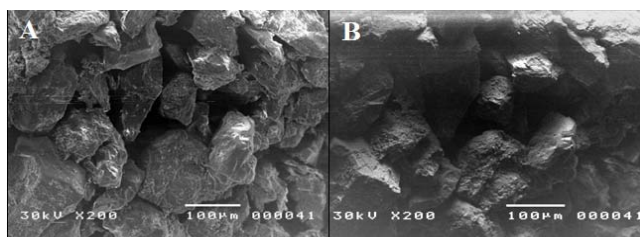
Fig. 14. SEM photomicrographs of sandstone sample from the temple of Seti I (200X):
A - Variable sizes of angular and sub-rounded particles of quartz;
B - The same field under BSE shows rough surface of quartz particles.

SEM photomicrograph shows variable sizes of quartz and under backscattered electrons (BSE), the particles have rough surface (Fig. 14). EDS analysis exhibits Si and O as the main elements, while Al, C, Ca, Cl, Fe, K, Na and S are presented in low different percentages. XRD analysis coincides with the former results, in which quartz is the major mineral, and traces of plagioclase, orthoclase, albite, calcite, microcline, hematite, thenardite and halite (Fig. 17 B). El-Gohary [10] analyzed sandstone samples from the temple of Ramesses II; XRF analysis shows that the main element is Si, then Fe and Ca, with few amounts of Al and Cl. In addition, XRD analysis shows that the main mineral is quartz and then calcite with the presence of kaolinite and albite in small quantities.

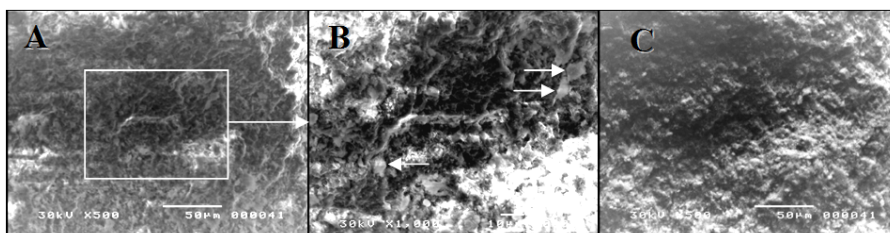
Fig. 15. SEM photomicrographs of mortar sample from the temple of Seti I:
A - Heterogeneous structure composed of fine grains (500X);
B - The same field under 1000X magnification shows the fine quartz particles;
C - The same field under BSE, 500X.

SEM photomicrograph shows heterogeneous structure composed of fine particles (Fig. 15). EDS analysis exhibits that C, Ca, O, S and Si are the main elements, with the presence of Al, Cl, K, Mg and Na in different low percentages. In line with this context, XRD analysis shows that gypsum, calcite and anhydrite are abundant in the sample, with traces of quartz, dolomite, kieselite and halite (Fig. 17C). Moreover, analyzed mortar sample from the temple of Seti I with XRD by Attia [15] shows that anhydrite was mainly detected with minor amounts of calcite and quartz.

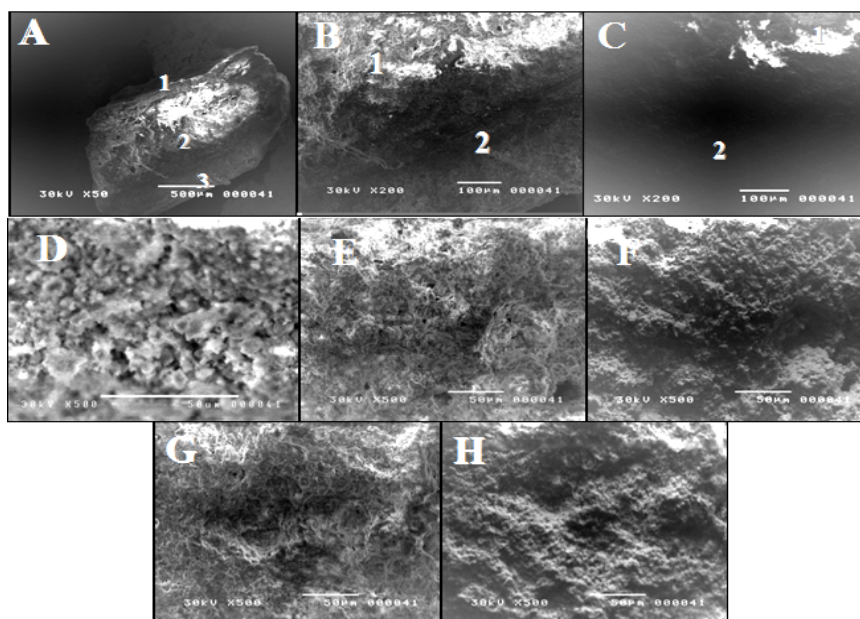
Fig. 16: SEM photomicrographs of different rendering samples from both temples:
A - Sample (S6R) shows three layers, *nos. 1 and 3* represent the clay layers and *no. 2* represents the lime layer (50X);
B - The same field focuses on the boundary between two layers (200X); C - The same field, under BSE, focuses on the clay layer "*no. 2*" with the presence of the lime layer "*no. 1*" (200X); D - Sample (S-Barques) shows fine grains that form homogeneous surface (500X); E - Sample (RR1) shows a coarse rendering composed of fine grains (500X);
F - The same field under BSE reveals cavities, which are distributed on the surface (500X); G - Sample (RKY) illustrates a coarse rendering (500X); H - The same field under BSE shows different cavities, which are distributed on the surface (500X).

By the examination with SEM, sample (S6R) shows three alternative layers composed of clay and lime. Samples (RR1) and (RKY) illustrate coarse renderings, which are characterized by surfaces with variable cavities, while sample (S-Barques) reveals homogeneous surface composed of fine grains (Fig. 16). In this respect, EDS analyses exhibit the following results: sample (S6B) contains C, O, Ca, Al, Si and S as the main elements, with the contribution of Cl, Fe, K, Mg, Na, and P. Sample (S-Barques) contains mainly Ca, O, C and Si, in addition to Al, Cl, K, Mg, Na and P. In sample (RKY), O, Ca, C and S, are present in high levels respectively, and traces of Al, Cl, Mg, Na and Si. The coarse sample (RR1) contains Ca, O, C, S and Si with the presence of Al, Cl, Cu, K, Mg and Na in small percentages.

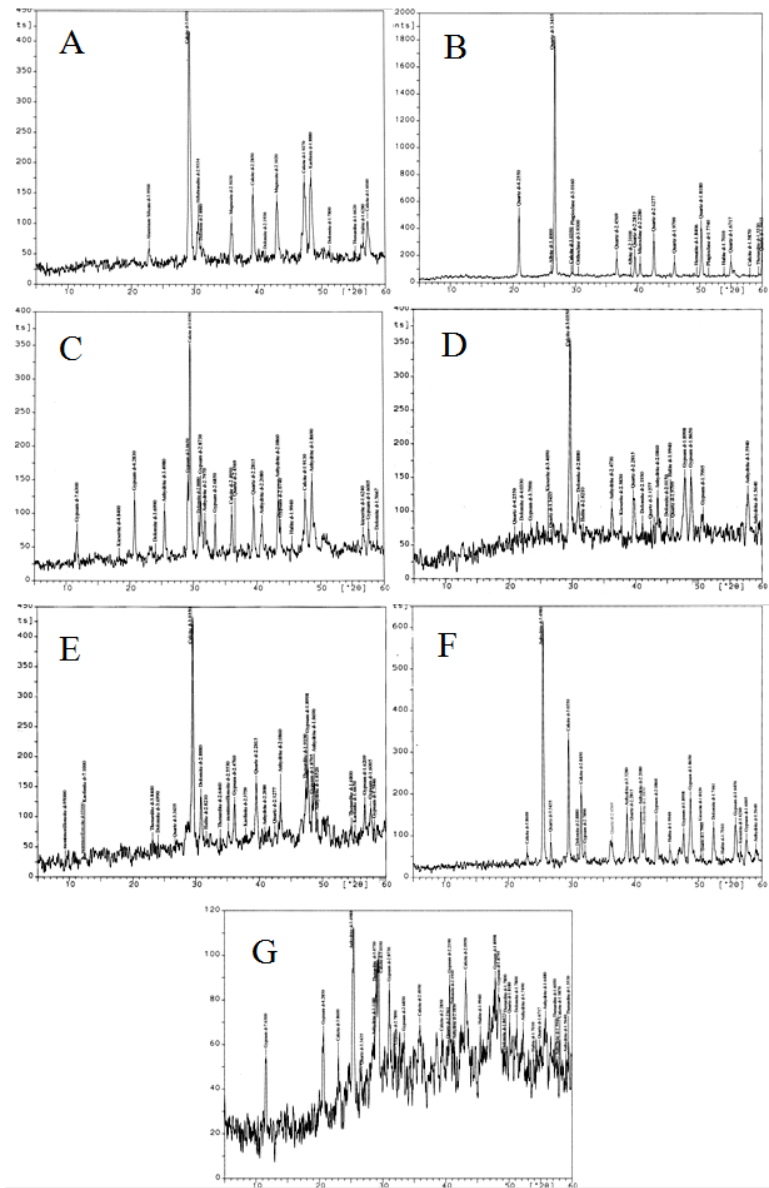
Fig. 17. XRD pattern of: A - limestone sample from the temple of Seti I; B - sandstone sample from the temple of Seti I; C - mortar sample from the temple of Seti I; D - the rendering sample (SY); E - the rendering sample (S6B); F - the rendering sample (RR1); G - the rendering sample (RKY).

Different rendering samples were analyzed by XRD technique, and the results are as follows: in sample (SY), the major minerals are calcite and gypsum, the minors are anhydrite, dolomite and quartz, and the traces are kieserite and halite. In sample (S6B), the majors are gypsum and calcite, and the minors are anhydrite, quartz, dolomite, kaolinite and montmorillonite, and the traces are thenardite and halite. In sample (RR1), the major mineral is anhydrite, the minors are calcite, gypsum and quartz, and the traces are dolomite, kieserite and halite. Finally in sample (RKY), the majors are gypsum, calcite and anhydrite, the minor is quartz, and the traces are dolomite, thenardite and halite (Fig. 17D, E, F and G). A rendering sample, analyzed by Attia [15], is obtained from the falling parts that cover the ceiling of one of the six small chapels in the temple of Seti I. This sample contains mainly anhydrite and minor amounts of quartz and calcite.
